**Flood Control Project Maintenance  
Levee Inspections****2015 Channel Summary Report****Overall Unit and Item Ratings****Fairfield Suisun Sewer District**

**Flood Control Project Maintenance****Unit Cover Sheet****2015 Channel Inspection Results****Fairfield Suisun Sewer District**

**Levee Inspection Report By Mile - Channel 2015**

**Fairfield Suisun Sewer District**

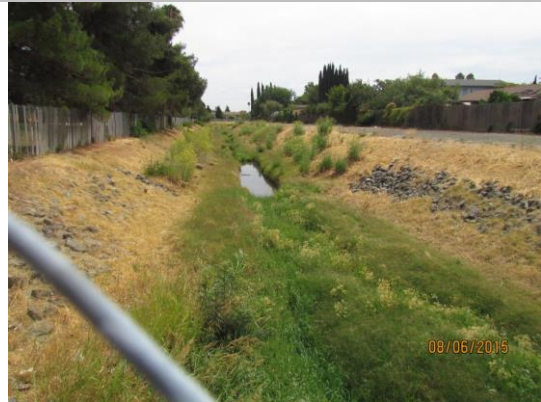
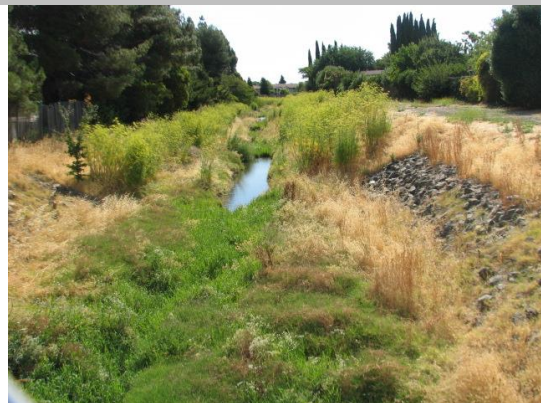
Inspector Comments: Minimal, scattered obstructions or vegetation. The flow is not impeded.

Looking downstream from Camrose Ave. Summer 2015.

A view downstream from Camrose Ave. Summer 2014

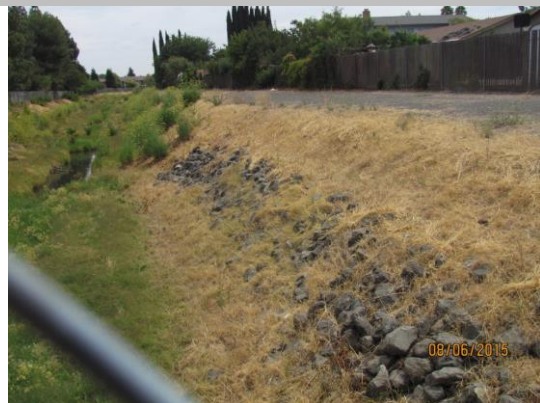
Photo 1 of 1 : CH\_2015\_NA0035\_16\_19\_20150817\_00020.jpg

Rating **	A	Issue No.	19	GPS Lat/Long
Issue Type +	Ma	Location *		38.281546
Category	Rivers, Channels & Designated Flood			-122.030544
Item	Revetments			
DWR ID	DWR_NA0035_16_c _ 2012_19			
Action/Comments				
Inspector Comments: Existing riprap protection is properly maintained and is undamaged. Riprap clearly visible.

View of the revetment on the right bank looking downstream. Summer 2015.

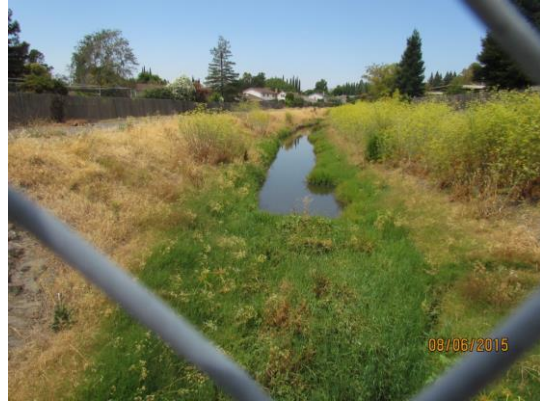
Photo 1 of 2 : CH\_2015\_NA0035\_16\_21\_20150817\_00021.jpg

Inspector Comments: Minimal, scattered obstructions or vegetation. The flow is not impeded.

Looking upstream from Dover Ave. Summer 2015.

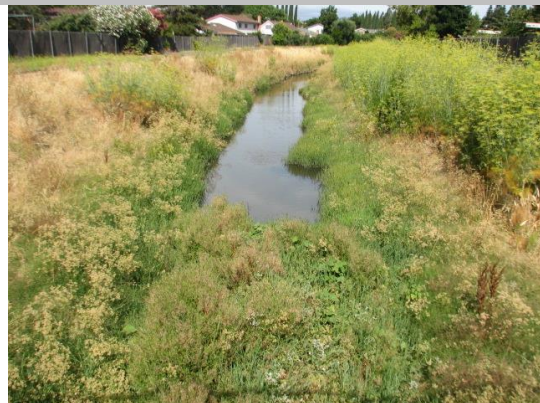
Photo 2 of 2 : CH\_2015\_NA0035\_16\_21\_20150612\_00008.jpg

A view looking upstream from Dover Ave. Summer 2014

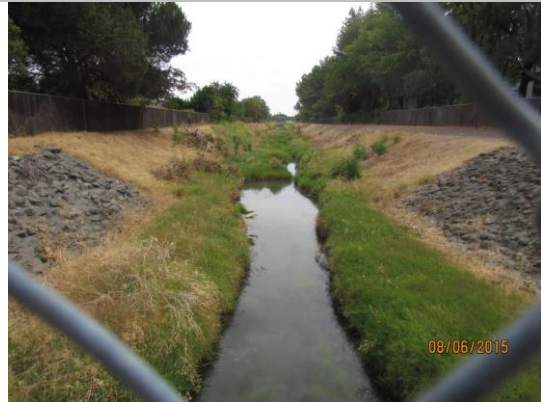
Photo 1 of 2 : CH\_2015\_NA0035\_16\_26\_20150817\_00022.jpg

Rating **	A	Issue No.	26	GPS Lat/Long
Issue Type +	Ma	Location *		38.280946 °
Category	Rivers, Channels & Designated Flood			-122.025034 °
Item	Vegetation & Obstructions			
DWR ID	DWR_NA0035_16_c _ 2012_26			
Action/Comments				
Inspector Comments: Minimal, scattered obstructions or vegetation. The flow is not impeded.

Looking downstream from Dover Ave. Woody vegetation has been removed. Summer 2015.

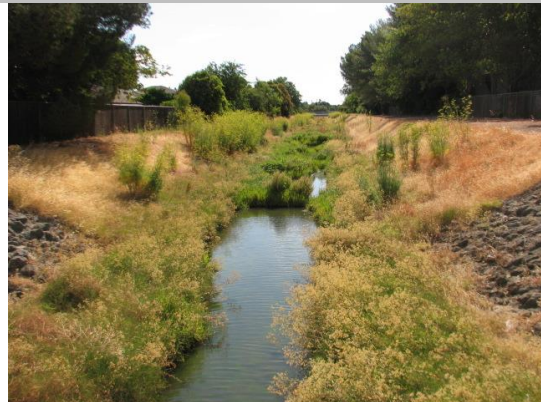
Photo 2 of 2 : CH\_2015\_NA0035\_16\_26\_20150612\_00010.jpg

Looking downstream from Dover Ave. Summer 2014. Remove small woody vegetation.

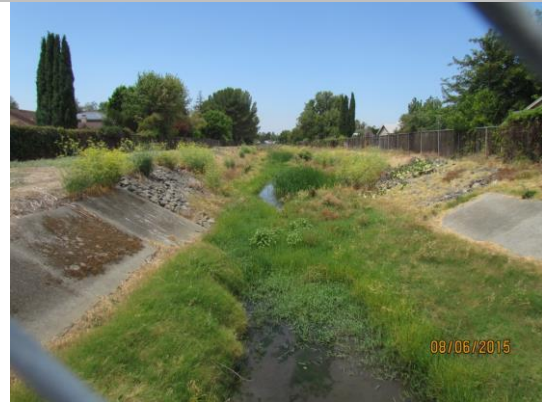
Photo 1 of 2 : CH\_2015\_NA0035\_16\_31\_20150817\_00023.jpg

Inspector Comments: Minimal, scattered obstructions or vegetation. The flow is not impeded.

Looking upstream from Gulf Dr. Summer 2015.

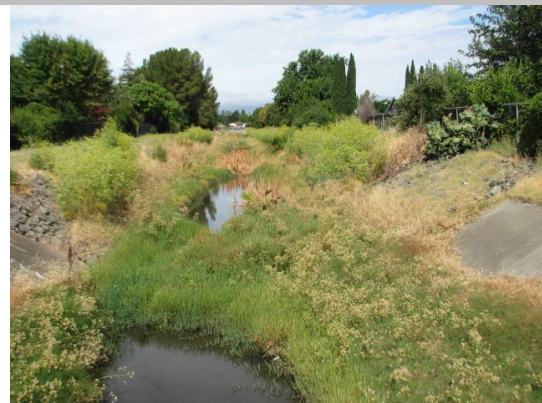
Photo 2 of 2 : CH\_2015\_NA0035\_16\_31\_20150612\_00012.jpg

A view looking upstream from Gulf Dr. Summer 2014

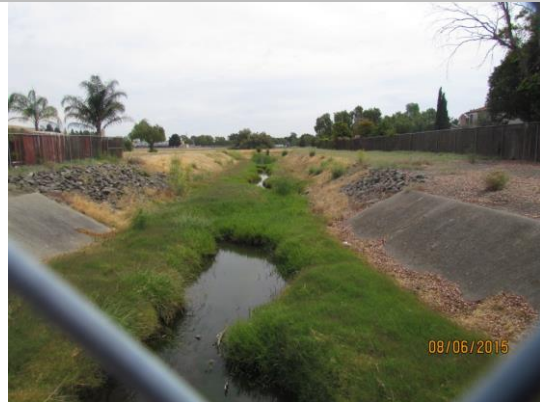
Photo 1 of 2 : CH\_2015\_NA0035\_16\_36\_20150817\_00024.jpg

Rating **	A	Issue No.	36	GPS Lat/Long
Issue Type +	Ma	Location *		38.280937 °
Category	Rivers, Channels & Designated Flood			-122.020629 °
Item	Vegetation & Obstructions			
DWR ID	DWR_NA0035_16_c_2012_36			
Action/Comments				
Inspector Comments: Minimal, scattered obstructions or vegetation. The flow is not impeded.

Looking downstream from Gulf Dr. Summer 2015.

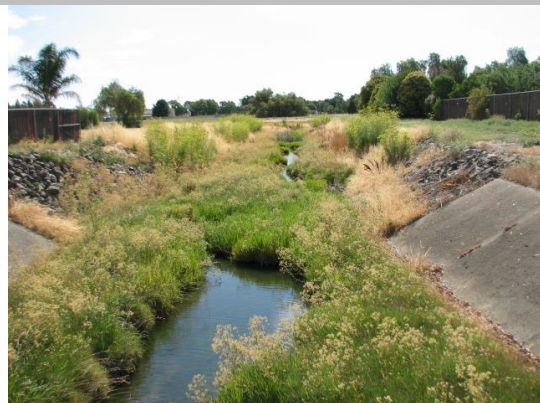
Photo 2 of 2 : CH\_2015\_NA0035\_16\_36\_20150612\_00014.jpg

A view looking downstream from Gulf Dr. Summer 2014
